Re: **Arista Group LLC/Sonoma Ranch East Phase 9; CGP; SIC 1521; NPDES Compliance Evaluation Inspection; NPDES #NMU001985; February 13, 2019**

NPDES Compliance Inspection Report

**Arista Group LLC
Sonoma Ranch East Phase 9
Compliance Evaluation Inspection
February 13, 2019
NPDES Permit No. NMU0001985
Further Explanations**

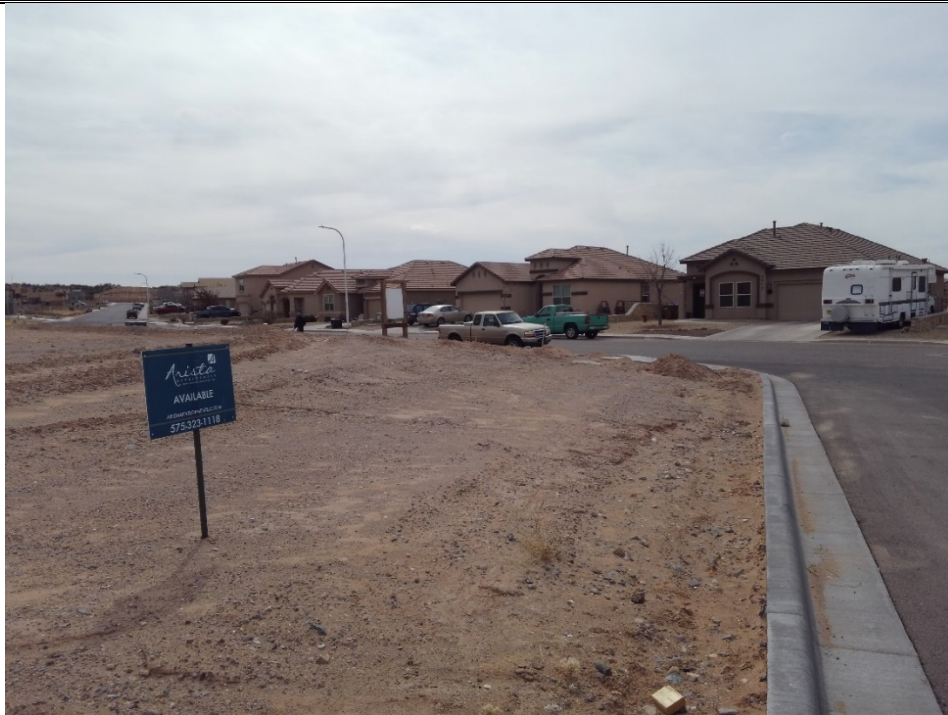
NMED/SWQB Official Photograph Log		
Photo # 1		
Photographer: Jennifer Foote	Date: 2/13/19	Time: 1:04 pm
City/County: Las Cruces/Dona Ana		State: New Mexico
Location: Sonoma Ranch East Phase 9		
Subject: berm around lot is insufficient and flows are leaving corner of site at handicap ramp

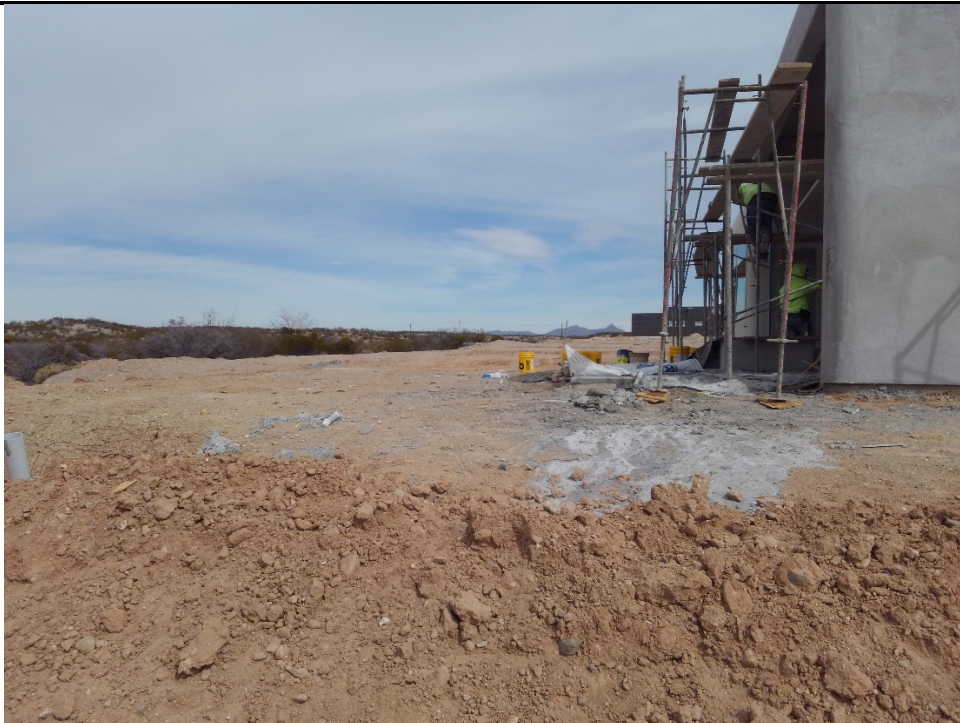
NMED/SWQB Official Photograph Log		
Photo # 2		
Photographer: Jennifer Foote	Date: 2/13/19	Time: 1:06 pm
City/County: Las Cruces/Dona Ana	State: New Mexico	
Location: Sonoma Ranch East Phase 9		
Subject: stucco washout directly on ground

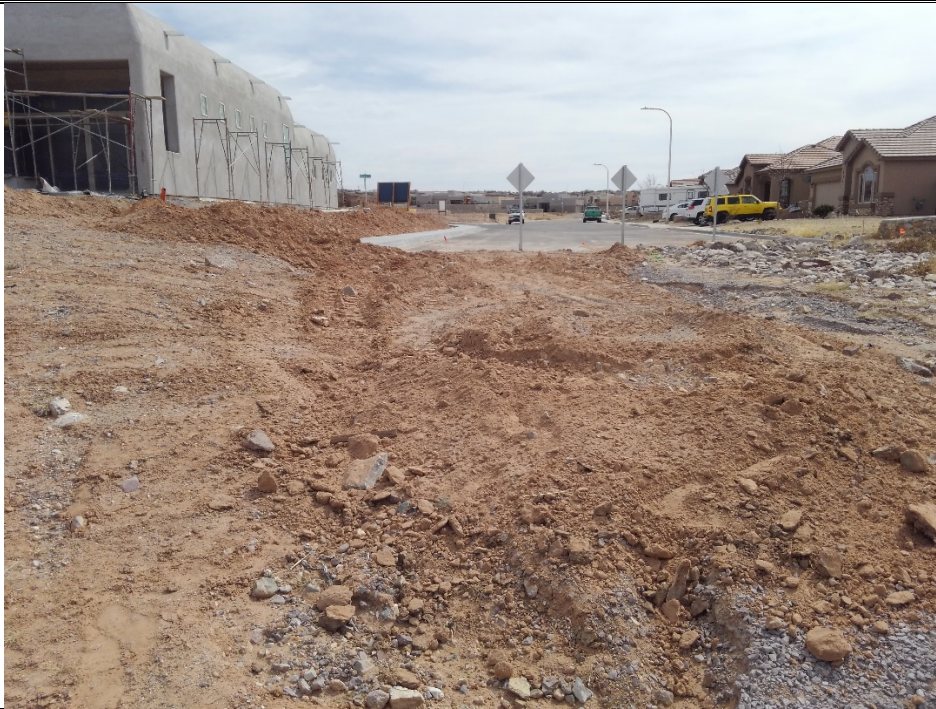
NMED/SWQB Official Photograph Log Photo # 3		
Photographer: Jennifer Foote	Date: 2/13/19	Time: 1:07 pm
City/County: Las Cruces/Dona Ana		State: New Mexico
Location: Sonoma Ranch East Phase 9		
Subject: disturbed soils adjacent to arroyo and rock drainage channel

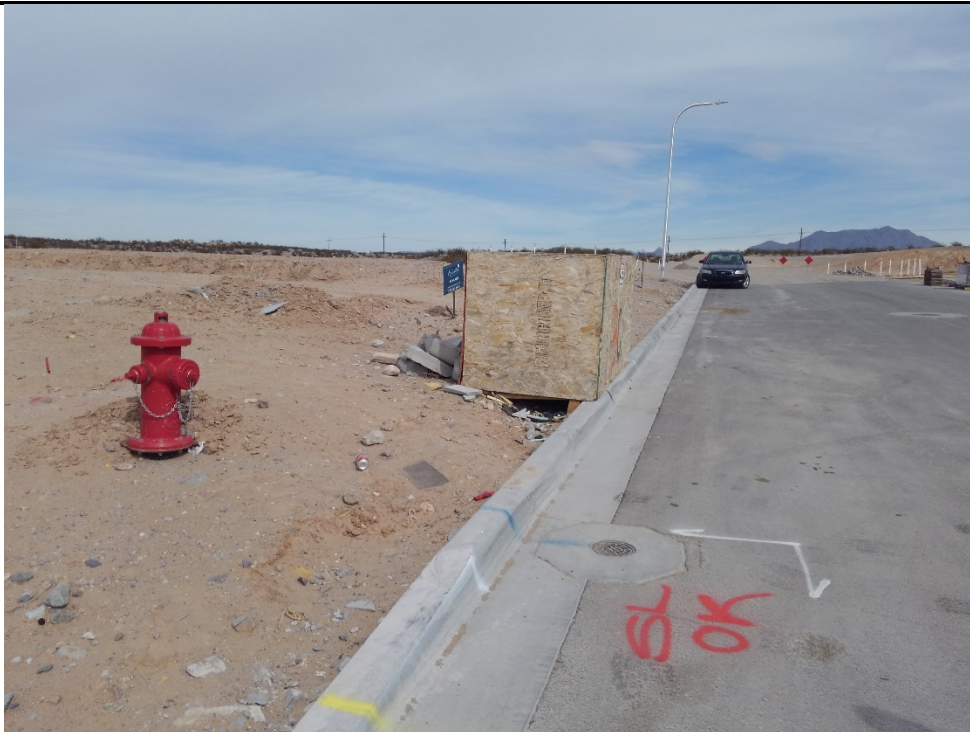
NMED/SWQB Official Photograph Log Photo # 4		
Photographer: Jennifer Foote	Date: 2/13/19	Time: 1:11 pm
City/County: Las Cruces/Dona Ana	State: New Mexico	
Location: Sonoma Ranch East Phase 9		
Subject: uncovered waste bin with bottom and trash falling out
